Report Number	xxx		
Windfarm	xxx		
Client	xxx		
Turbine Number	T20		
Turbine Type	GE1.5		
Blade Type	LM34		
Repair Technicians	xxx		
Repair Date(s)	From: 30-08-2021	To: 16-09-2021	
Report Date	10-09-2021		
Report Author	xxx		
Report Approver	Alex Mountain

Turbine Serial Number	37423
Turbine Serial Number Photo

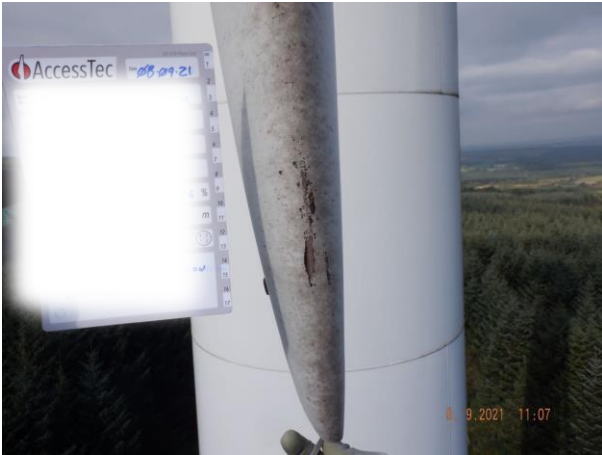
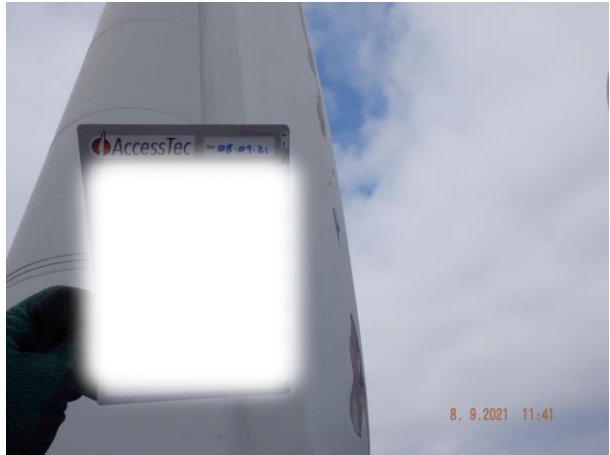
Blade Condition Prior to Repair	Blade Prepared
---------------------------------	----------------

Repair Summary
 Leading edge erosion was repaired with filler from 28m to the Tip.
 6 metres of 3M Wind Protection Tape was applied to the blade.

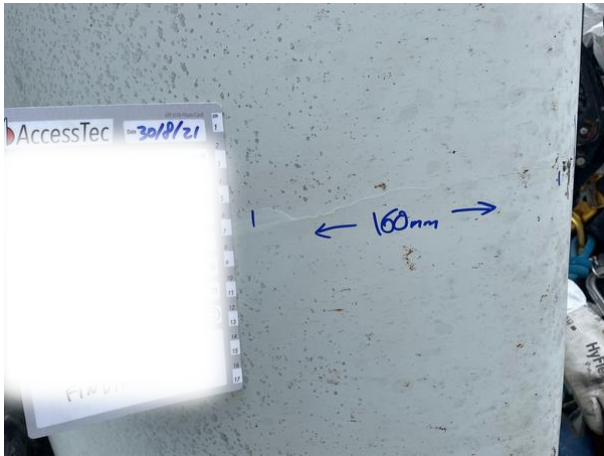
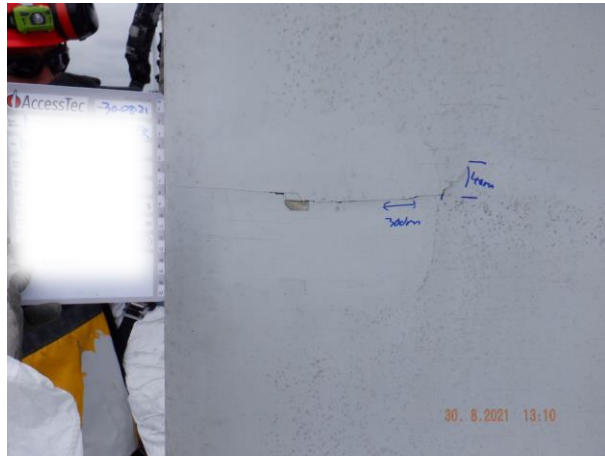
Suction Side	Pressure Side
Condition Prior to Repair	Condition Prior to Repair

<p>Repair Summary</p> <p>Defect - 347588</p> <p>The core material was tested and the defective material removed, during this process a crack in the inner laminate on both PS and SS (one layer of Biax) was found. The crack was prepared before a repair to the inner laminate was made using two layers of Biax.</p> <p>Core material was replaced and profiled.</p> <p>The external laminate was repaired with a layup consisting of 2 layers of UD 650 and 4 layers of Biax 600.</p> <p>The repair was post-cured to improve its mechanical properties, then filler was applied and profiled to restore blade geometry. A layer of paint was hand rolled to finish the repair.</p> <p>Defects - 347591, 347594 - Leading edge erosion was repaired with filler from 28m to the Tip.</p> <p>6 metres of 3M Wind Protection Tape was applied to the blade.</p>
--

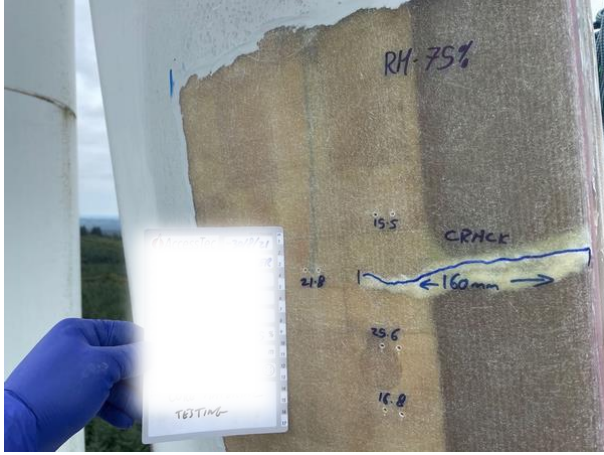
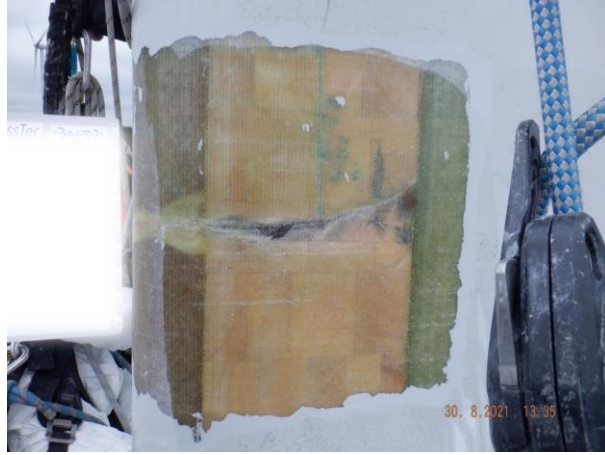
<p>RH-75%</p> <p>15.5</p> <p>CRACK</p> <p>← 160mm →</p> <p>21.8</p> <p>23.6</p> <p>16.8</p> <p>TESTING</p>

Crack on inner laminate	Crack on inner laminate
