<b>Windfarm</b>	Tournafulla		
<b>Client</b>	SSE		
<b>Turbine Number</b>	2		
<b>Turbine Type</b>	GE 1.5		
<b>Blade Supplier</b>	LM		
<b>Blade Type</b>	LM 34		
<b>Blade Serial Numbers</b>	<b>A</b> 2658	<b>B</b> 2663	<b>C</b> 2665
<b>Technicians</b>	Duncan Izatt, Pietro Pavese, Blaise Harvey, Stefan Morris, Phil Beddow		
<b>Inspection Date</b>	26-07-2022		
<b>Report Author</b>	Duncan Izatt, Pietro Pavese, Blaise Harvey, Stefan Morris		
<b>Report Approver</b>	Alex Mountain

### Summary

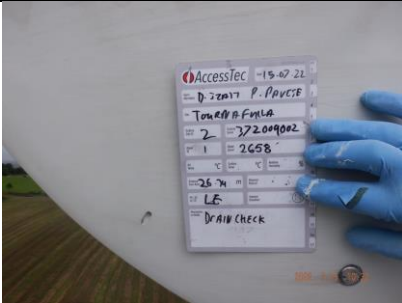
<b>Drain Hole on Arrival</b>	<b>Drain Hole Cleared</b>

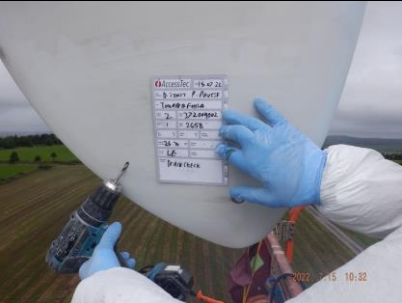
Pass, Drain hole cleared

The drain hole was cleared using a drill, with an appropriately sized bit.
