Report Number	xxx		
Windfarm	xxx		
Client	xxx		
Turbine Number	T22		
Turbine Type	Siemens 2.3mw		
Blade Type	Siemens B40		
Repair Technicians	xxx		
Installation Date(s)	From: xxx	To: xxx	
Report Date	09-10-2020		
Report Author	xxx		
Report Approver	Alex Mountain

Blade Number	xxx
Blade Designation	A
Blade Badge

Installation Summary
<p>Package A of Aero Upgrades were fitted to all three blades of T22.</p> <p>This consisted of Winglets, Spoiler, Gurney Flaps & Fence.</p> <p>Work was carried out in accordance with:</p> <ul style="list-style-type: none"> - ATP-018 ANAKATA Gurney Flap Installation rev1 - ATP-019 ANAKATA Spoiler Installation rev1 - ATP-020 ANAKATA Winglet Installation rev1 - ATP-021 ANAKATA Fence Installation rev1 <p>Access method:</p> <ul style="list-style-type: none"> - MEWP for the Winglets - Rope Access for Spoiler, Gurney Flaps and Fence. <p>LPS readings were within the required range.</p>

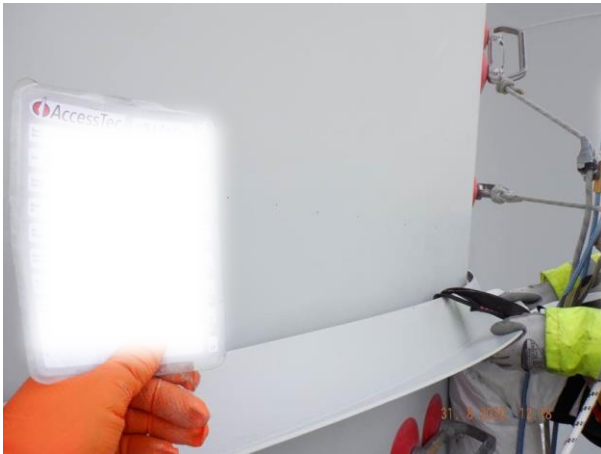
Intersect/Start Point	Surface Prepared

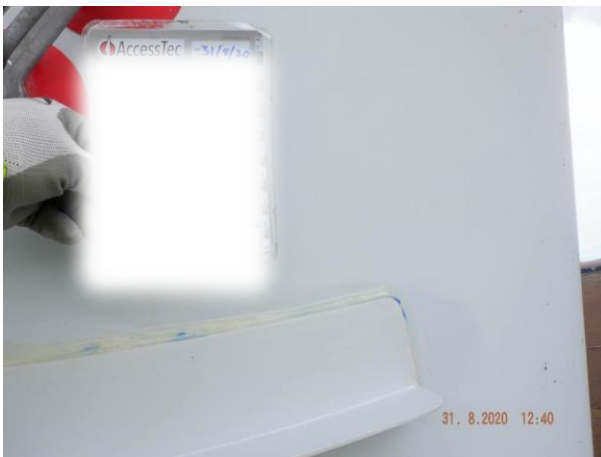
Example Sealing	Overview of Complete Installation

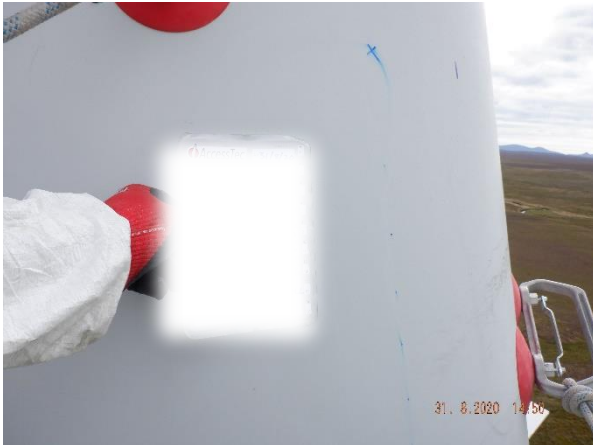
Intersect/Start Point	Example Sealing

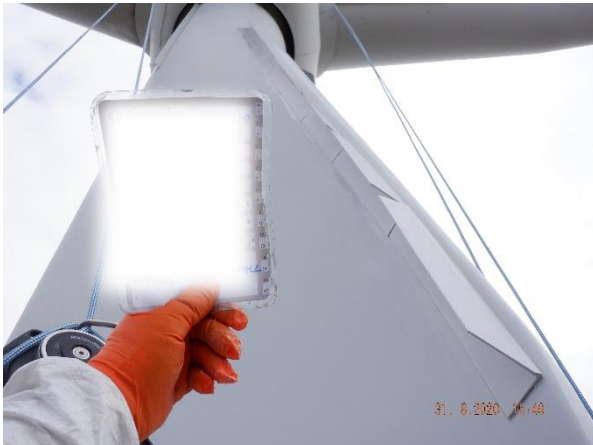
Upper Section Installed (above max chord)	Overview of Complete Installation

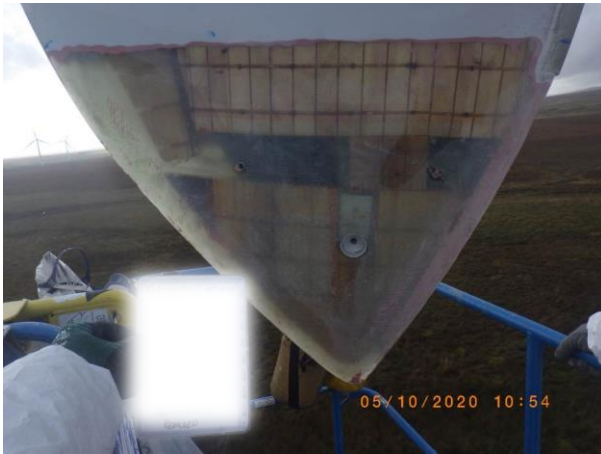
Filler and Paint Removed	Hole Drilled Through the Block/Blade

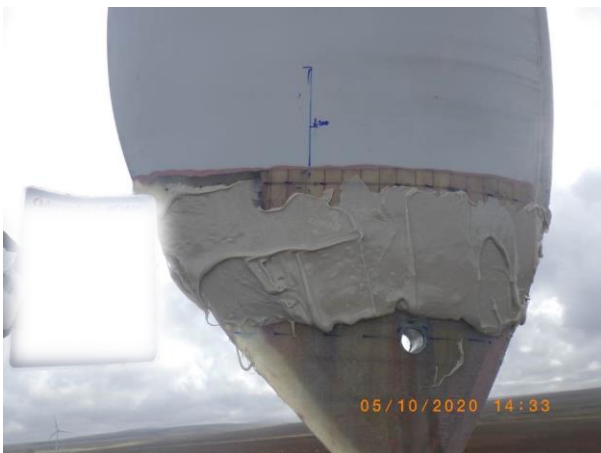
Adhesive Applied to the Blade	Filler Applied Between the Winglet and the Blade

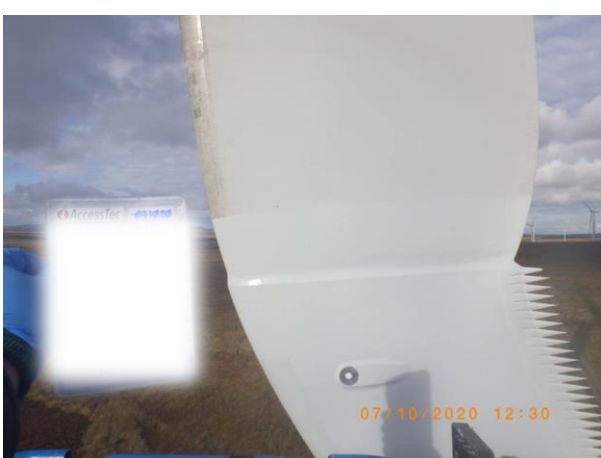
Winglet Installed PS	Winglet Installed SS
