Report Number	xxx		
Windfarm	xxx		
Client	xxx		
Turbine Number	T20		
Turbine Type	GE1.5		
Blade Type	LM34		
Repair Technicians	xxx		
Repair Date(s)	From: 30-08-2021	To: 16-09-2021	
Report Date	10-09-2021		
Report Author	xxx		
Report Approver	Alex Mountain

Turbine Serial Number	37423
Turbine Serial Number Photo

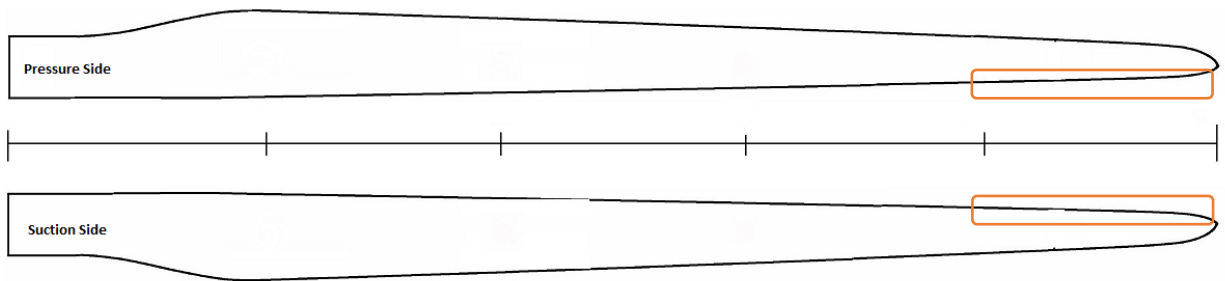
Blade 1 Repair Table					
Repair #	Distance from root (m)	Location (LE, PS, TE, SS)	Damage/Repair Type	Length (mm)	Width (mm)
347517	28	LE	Leading edge erosion	6000	100
347518

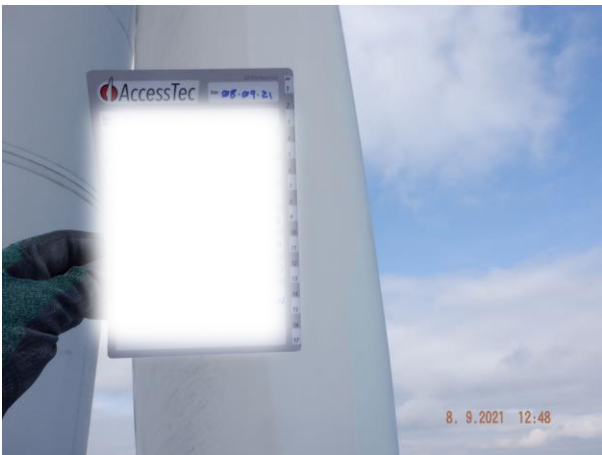
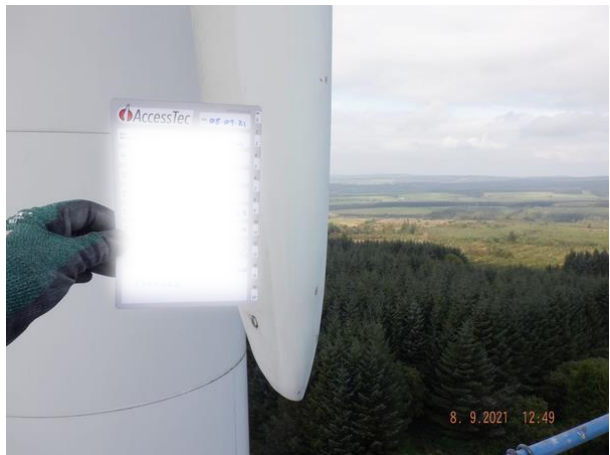
Repair Complete	Repair Complete
-----------------	-----------------

Repair Summary
 Leading edge erosion was repaired with filler from 28m to the Tip.
 6 metres of 3M Wind Protection Tape was applied to the blade.

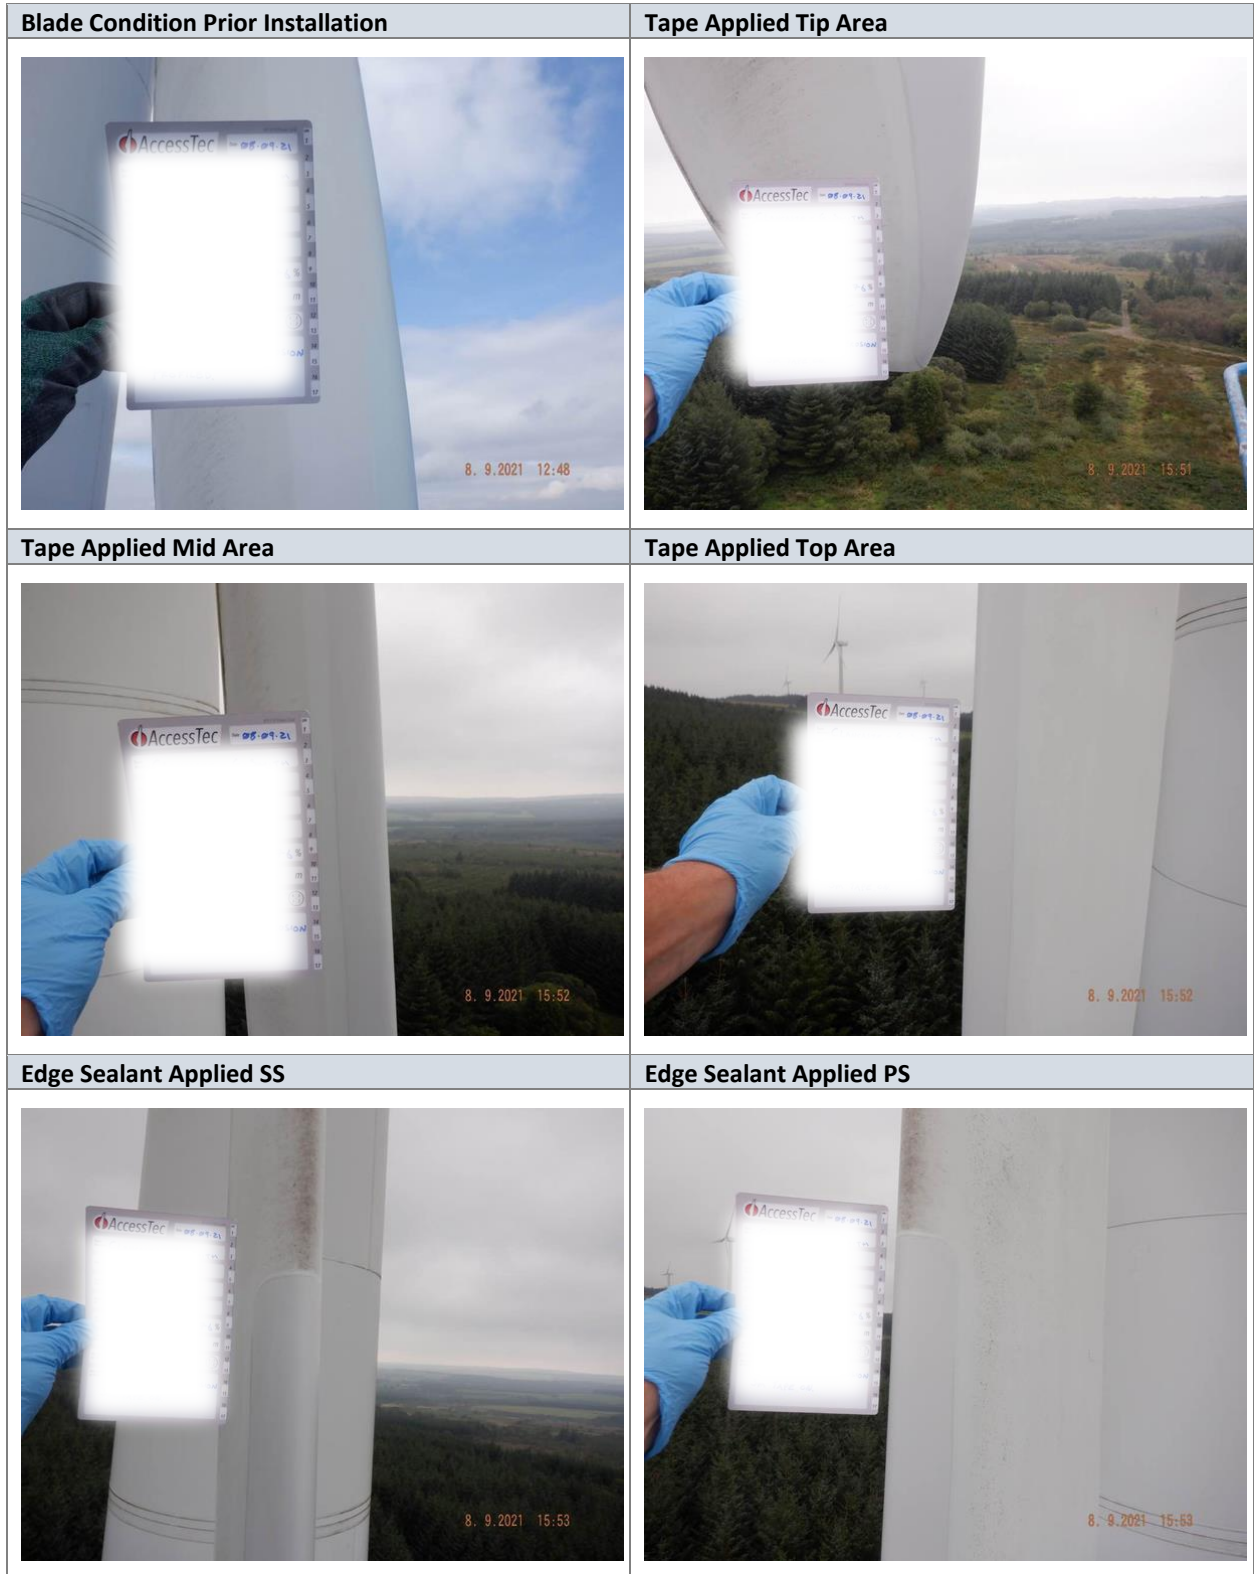
Blade	Repair #	Metres Applied (m)	Date Applied
1	3M LEP Installation	6	08-09-2021

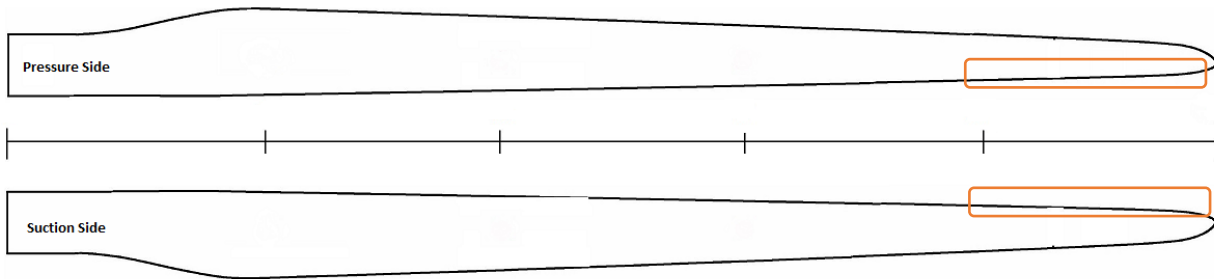
Blade 2 Repair Table					
Repair #	Distance from root (m)	Location (LE, PS, TE, SS)	Damage/Repair Type	Length (mm)	Width (mm)
347534	28	LE	Leading edge erosion	6000	100
347535

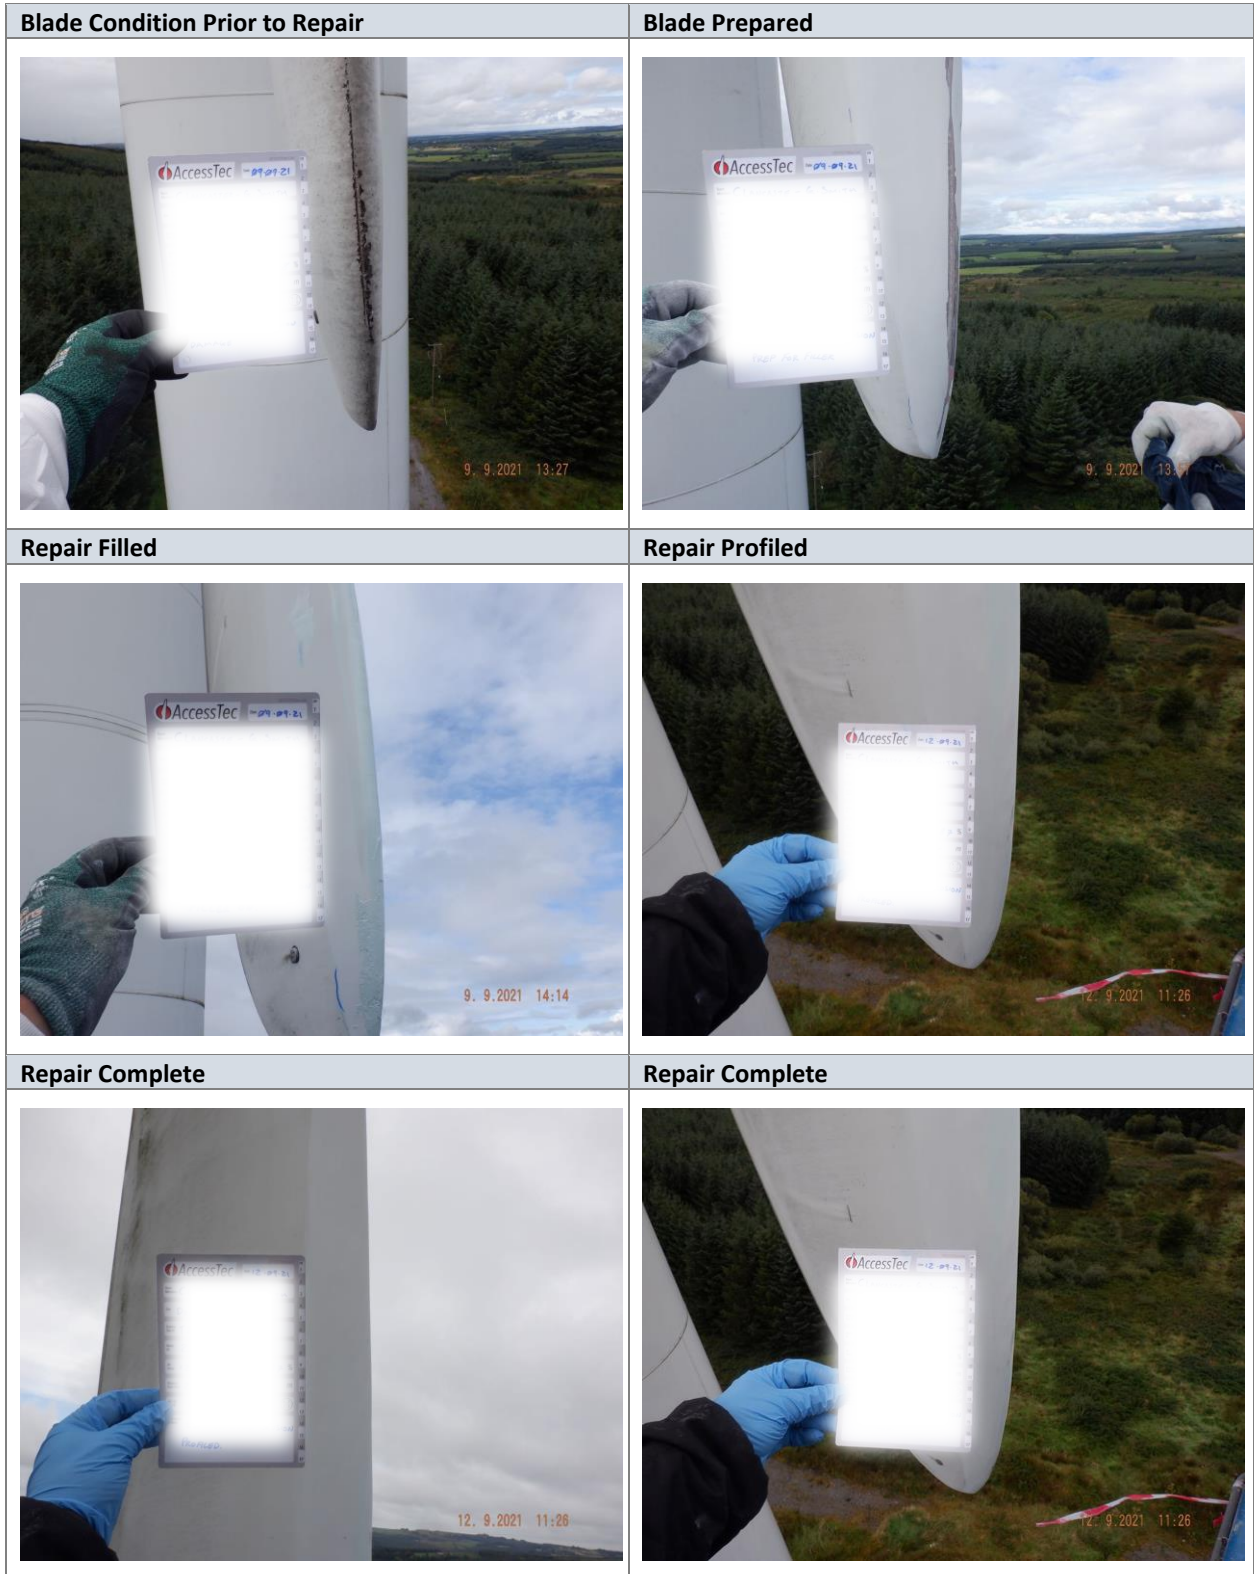
Blade	Repair #	Distance from root (m)	Location	Damage/Repair Type
2	347534, 347535	28 - 34	LE	Leading edge erosion

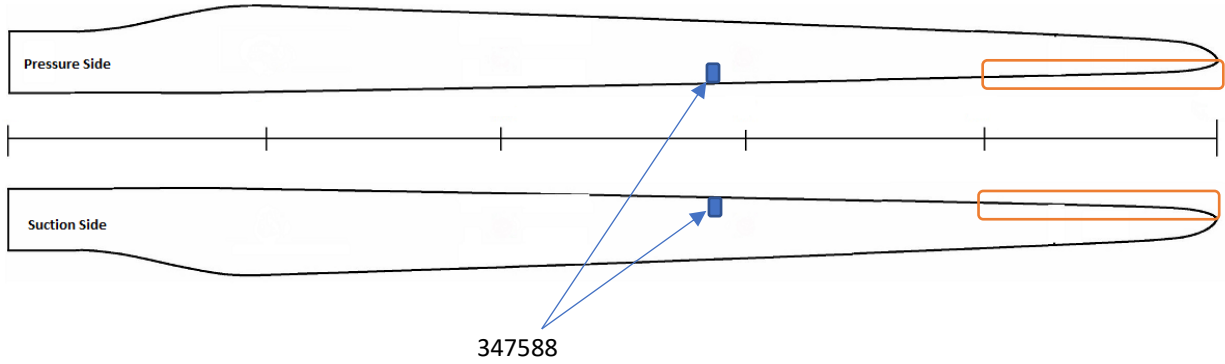
<p>Repair Summary</p> <p>Defect - 347588</p> <p>The core material was tested and the defective material removed, during this process a crack in the inner laminate on both PS and SS (one layer of Biax) was found. The crack was prepared before a repair to the inner laminate was made using two layers of Biax.</p> <p>Core material was replaced and profiled.</p> <p>The external laminate was repaired with a layup consisting of 2 layers of UD 650 and 4 layers of Biax 600.</p> <p>The repair was post-cured to improve its mechanical properties, then filler was applied and profiled to restore blade geometry. A layer of paint was hand rolled to finish the repair.</p> <p>Defects - 347591, 347594 - Leading edge erosion was repaired with filler from 28m to the Tip.</p> <p>6 metres of 3M Wind Protection Tape was applied to the blade.</p>
--

Blade 3 Repair Table					
Repair #	Distance from root (m)	Location (LE, PS, TE, SS)	Damage/Repair Type	Length (mm)	Width (mm)
347591, 347594	28 - 34	LE	Leading edge erosion	6000	100
347588	20	PS	Crack	599	500
347588	20	SS	Crack	580	305

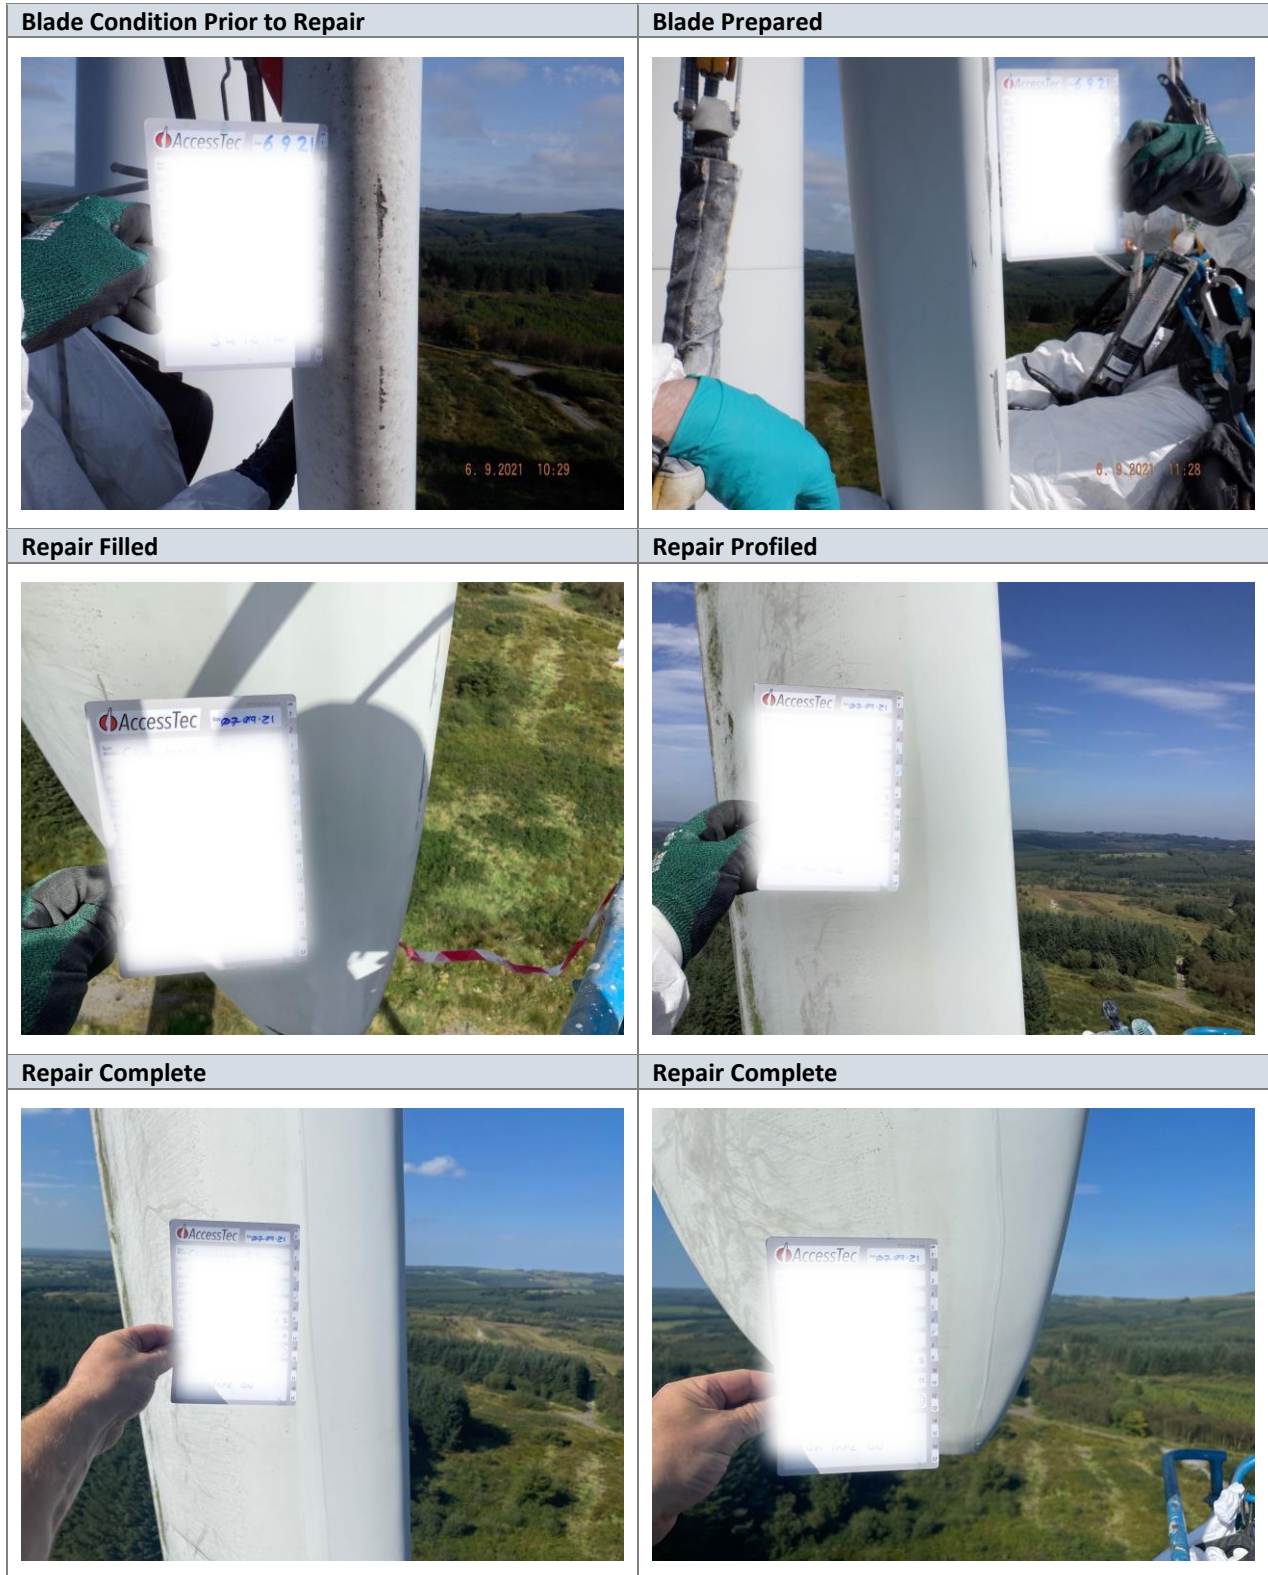
Blade	Repair #	Distance from root	Location	Damage/Repair Type
3	347588	28	LE	Leading edge erosion

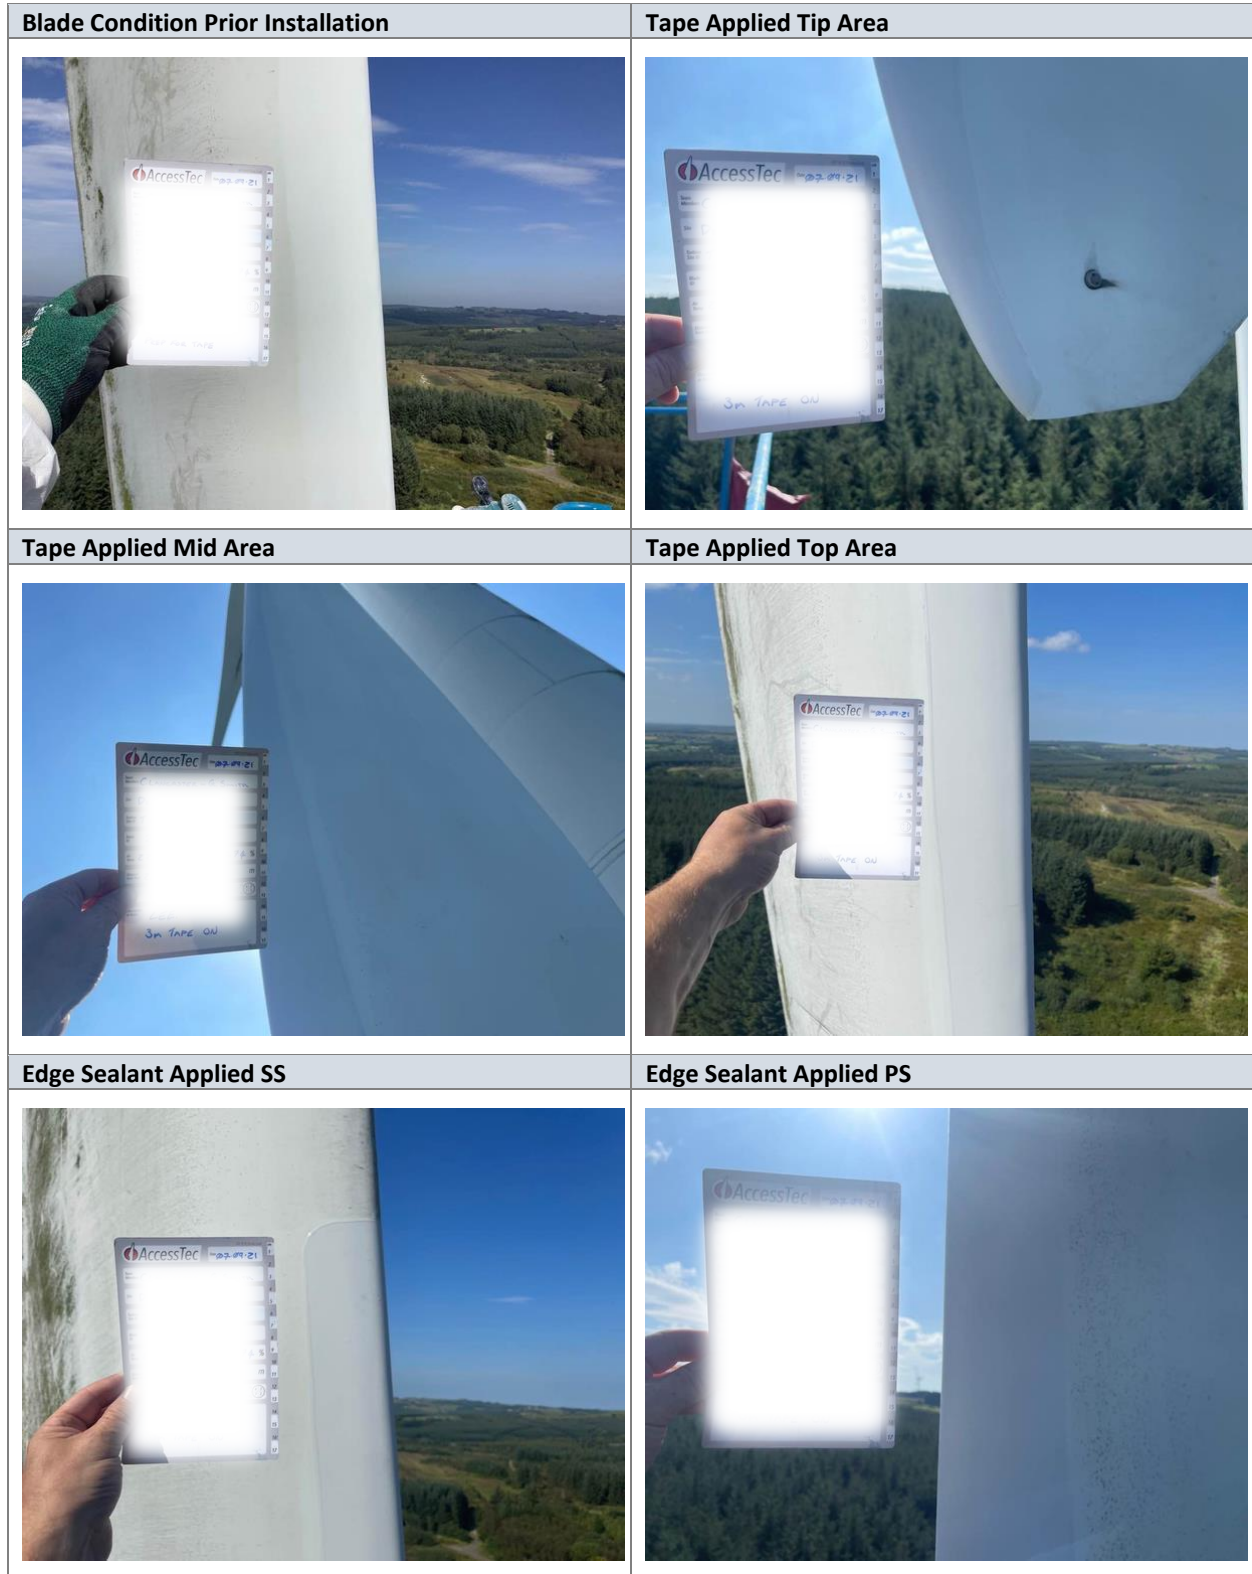
Blade	Repair #	Metres Applied (m)	Date Applied
3	3M LEP Installation	6	07-09-2021
